1. Project Name: Kihei Beach SPP

2. Date of Inspection: June 26, 2002

CONTINUING ELIGIBILITY INSPECTION (CEI) REPORT FOR HURRICANE & SHORE PROTECTION PROJECTS Honolulu Engineer District CEPOH-EC-T

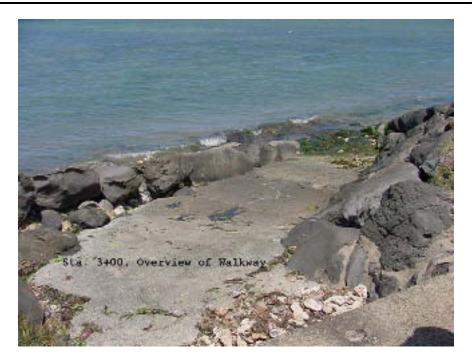
b. Sta. 3+00, 1st Walkway, photo for reference.

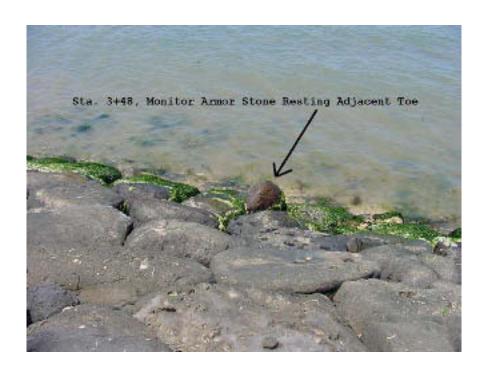
c. Sta. 3+48, Monitor the armor stone resting adjacent the toe.

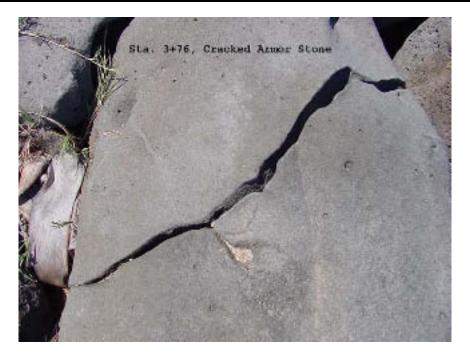
d. Sta. 3+76, Monitor the area adjacent to cracked armor stone for settling.

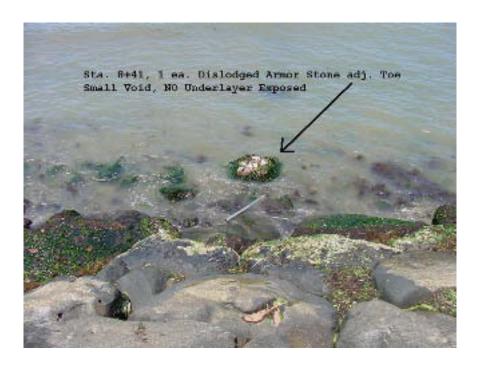
e. Sta. 8+41, Monitor the dislodged armor stone adjacent the toe.

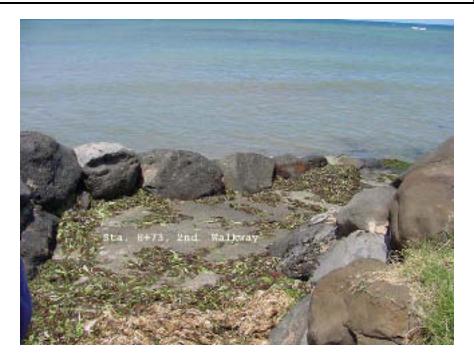
f. Sta. 8+73, 2nd Walkway, photo for reference.

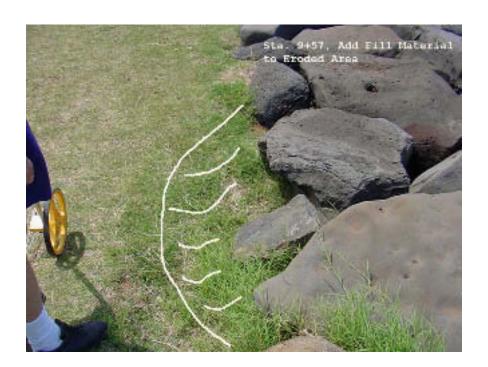
g. Sta. 9+57, Add fill material to the eroded area.

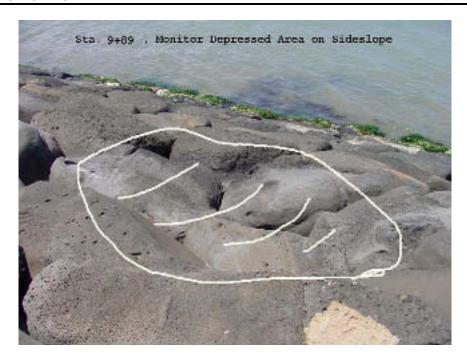
h. Sta. 9+89, Monitor the depressed area on sideslope.

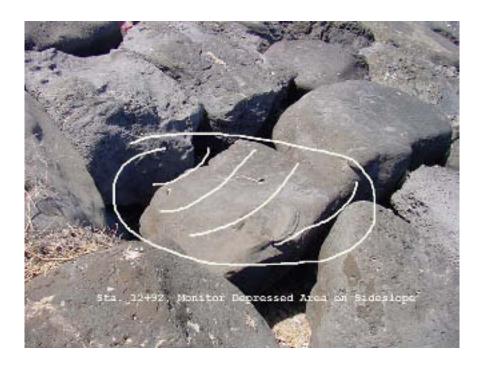
i. Sta. 12+92, Monitor the depressed area on sideslope.

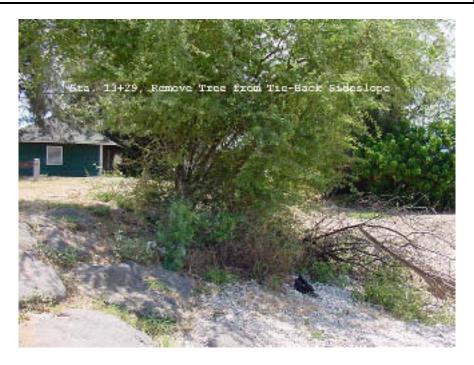
j. Sta. 13+29, Remove the tree from tie-back sideslope.

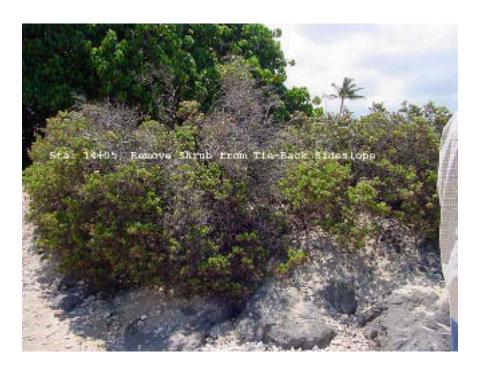
k. Sta. 14+05, Remove the vegetation from tie-back sideslope.

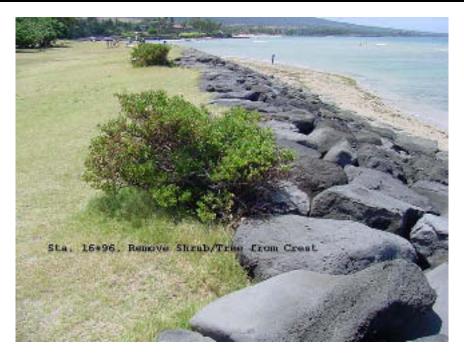
1. Sta. 16+96, Remove the vegetation from crest.

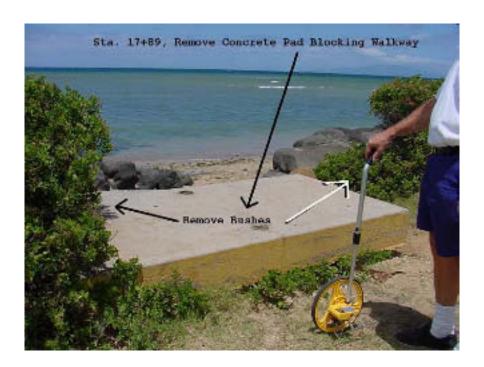
m. Sta. 17+89, Remove the concrete pad and vegetation.

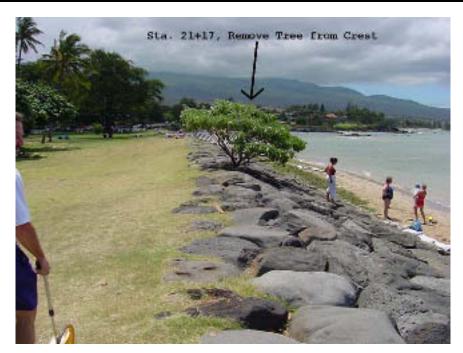
n. Sta. 21+17, Remove the tree from the crest.

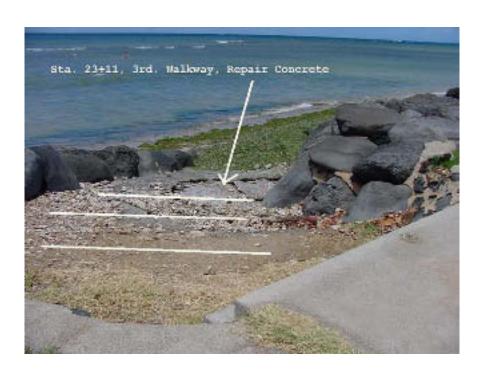
o. Sta. 23+11, 3rd Walkway, repair the concrete invert.

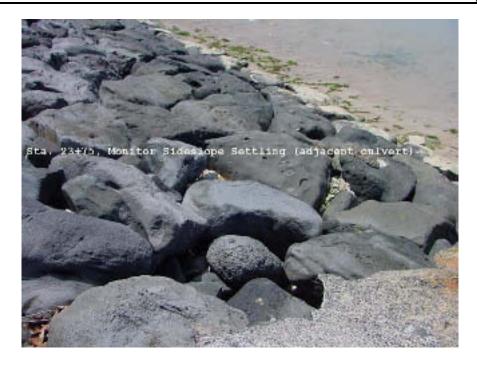
p. Sta. 23+75, Monitor the sideslope settling on the southside of the culvert.

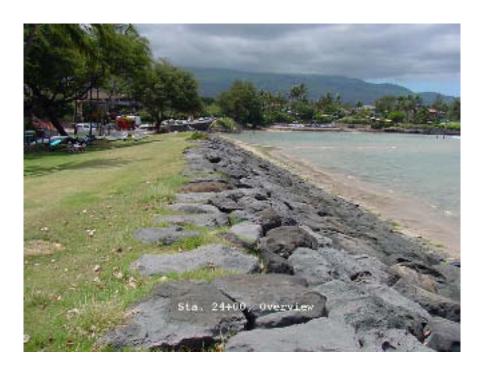
q. Sta. 24+00, Overview, photo for reference.

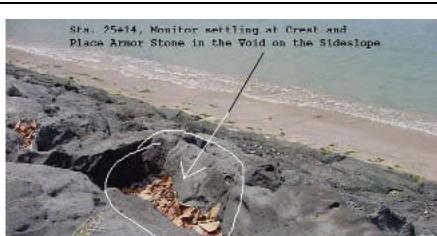
r. Sta. 25+14, Reset the missing armor stone and monitor area for settling.

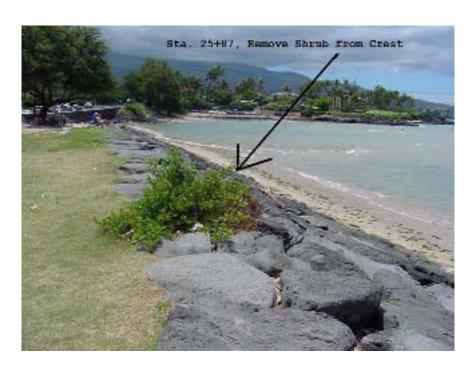
s. Sta. 25+87, Remove the vegetation from crest.

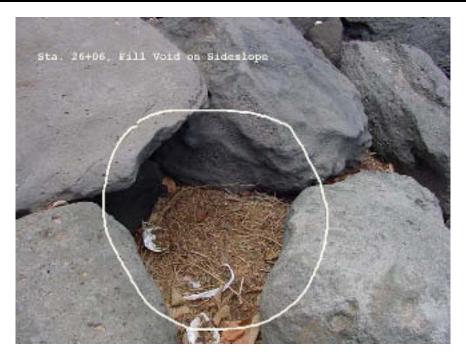
t. Sta. 26+06, Reset the missing armor stone.

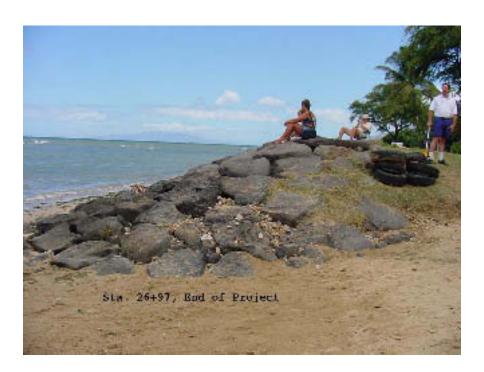
u. Sta. 26+97, End of project (south), photo for reference.
